ENDANGERED SPECIES OBSERVER PROGRAM

Project: 22 of Simon's Channel, Pronswick GA

## INCIDENT REPORT OF SEA TURTLE TAKE BY DREDGING ACTIVITY

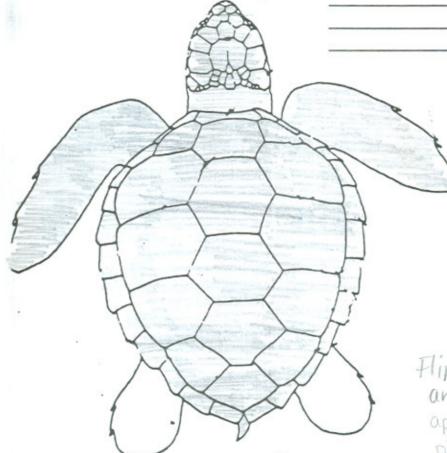
Head Width	
Plastron Length N/h	Width
	S.L. Width
	O.C. Width
Turtle Tagged? Yes No Tag#_	
Comments	
We estimate that the death of th	is individual occurred within the last
24 hours or so. There have been up	to 13 shrimp trawlers Working
in and around the channel in the	
attribute the death of this turtle to de	
Observer's Name Macking M. Pierry	v /

Date 01-03-99	
species Loggerhead	
Time found 1000	
load # 152	
vessel name: Newbort	
Company: Manson	
H.D. teno: 54° F

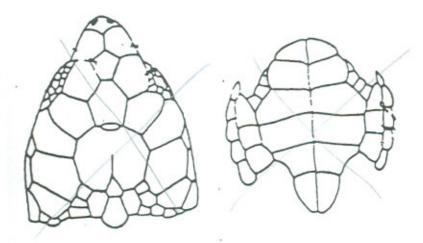
Flippers connected by tissue and a few bones only. Bones appear sandblasted. Muscle pink - no dripping blood.
